Assessment of Bronx River Ecosystem: pre-restoration baseline data  
Susannah Cox  
Problems and Projects in Environmental Science  
Peter Bower  
8 May, 1998

**Abstract-** The Bronx river displays many visible signs of being a severely degraded waterway. This study was to collect baseline data on the condition of one section of the river through examinations of soil and water conditions, and the benthic macroinvertebrate populations.

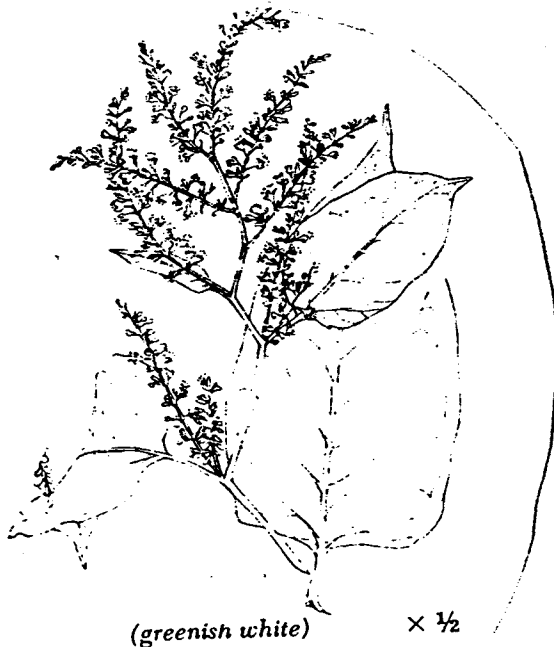
Fig. 4- Japanese knotweed from Newcomb's Wildflower Guide

within and downstream of the restoration site (NRG, 2). A major part of this project will involve eradication of the invasive exotic Japanese knotweed (*Polygonum cuspidatum*) which has invaded over 6.5 acres and has no ecological value other than holding the bank of the river together (figs. 4 & 5). Japanese knotweed is a native plant of eastern Asia that was introduced in America as an ornamental in the late 19th century (Randall, 77). It is extremely hardy and typically grows along urban riverbanks. It grows densely and quickly and reproduces by spreading rhizomes; the tiniest of which can grow into a new plant. Once Japanese knotweed becomes established, it typically precludes other plants from growing in its dense shade which results in a monoculture that native species of animals are repelled from (NRG, 3).

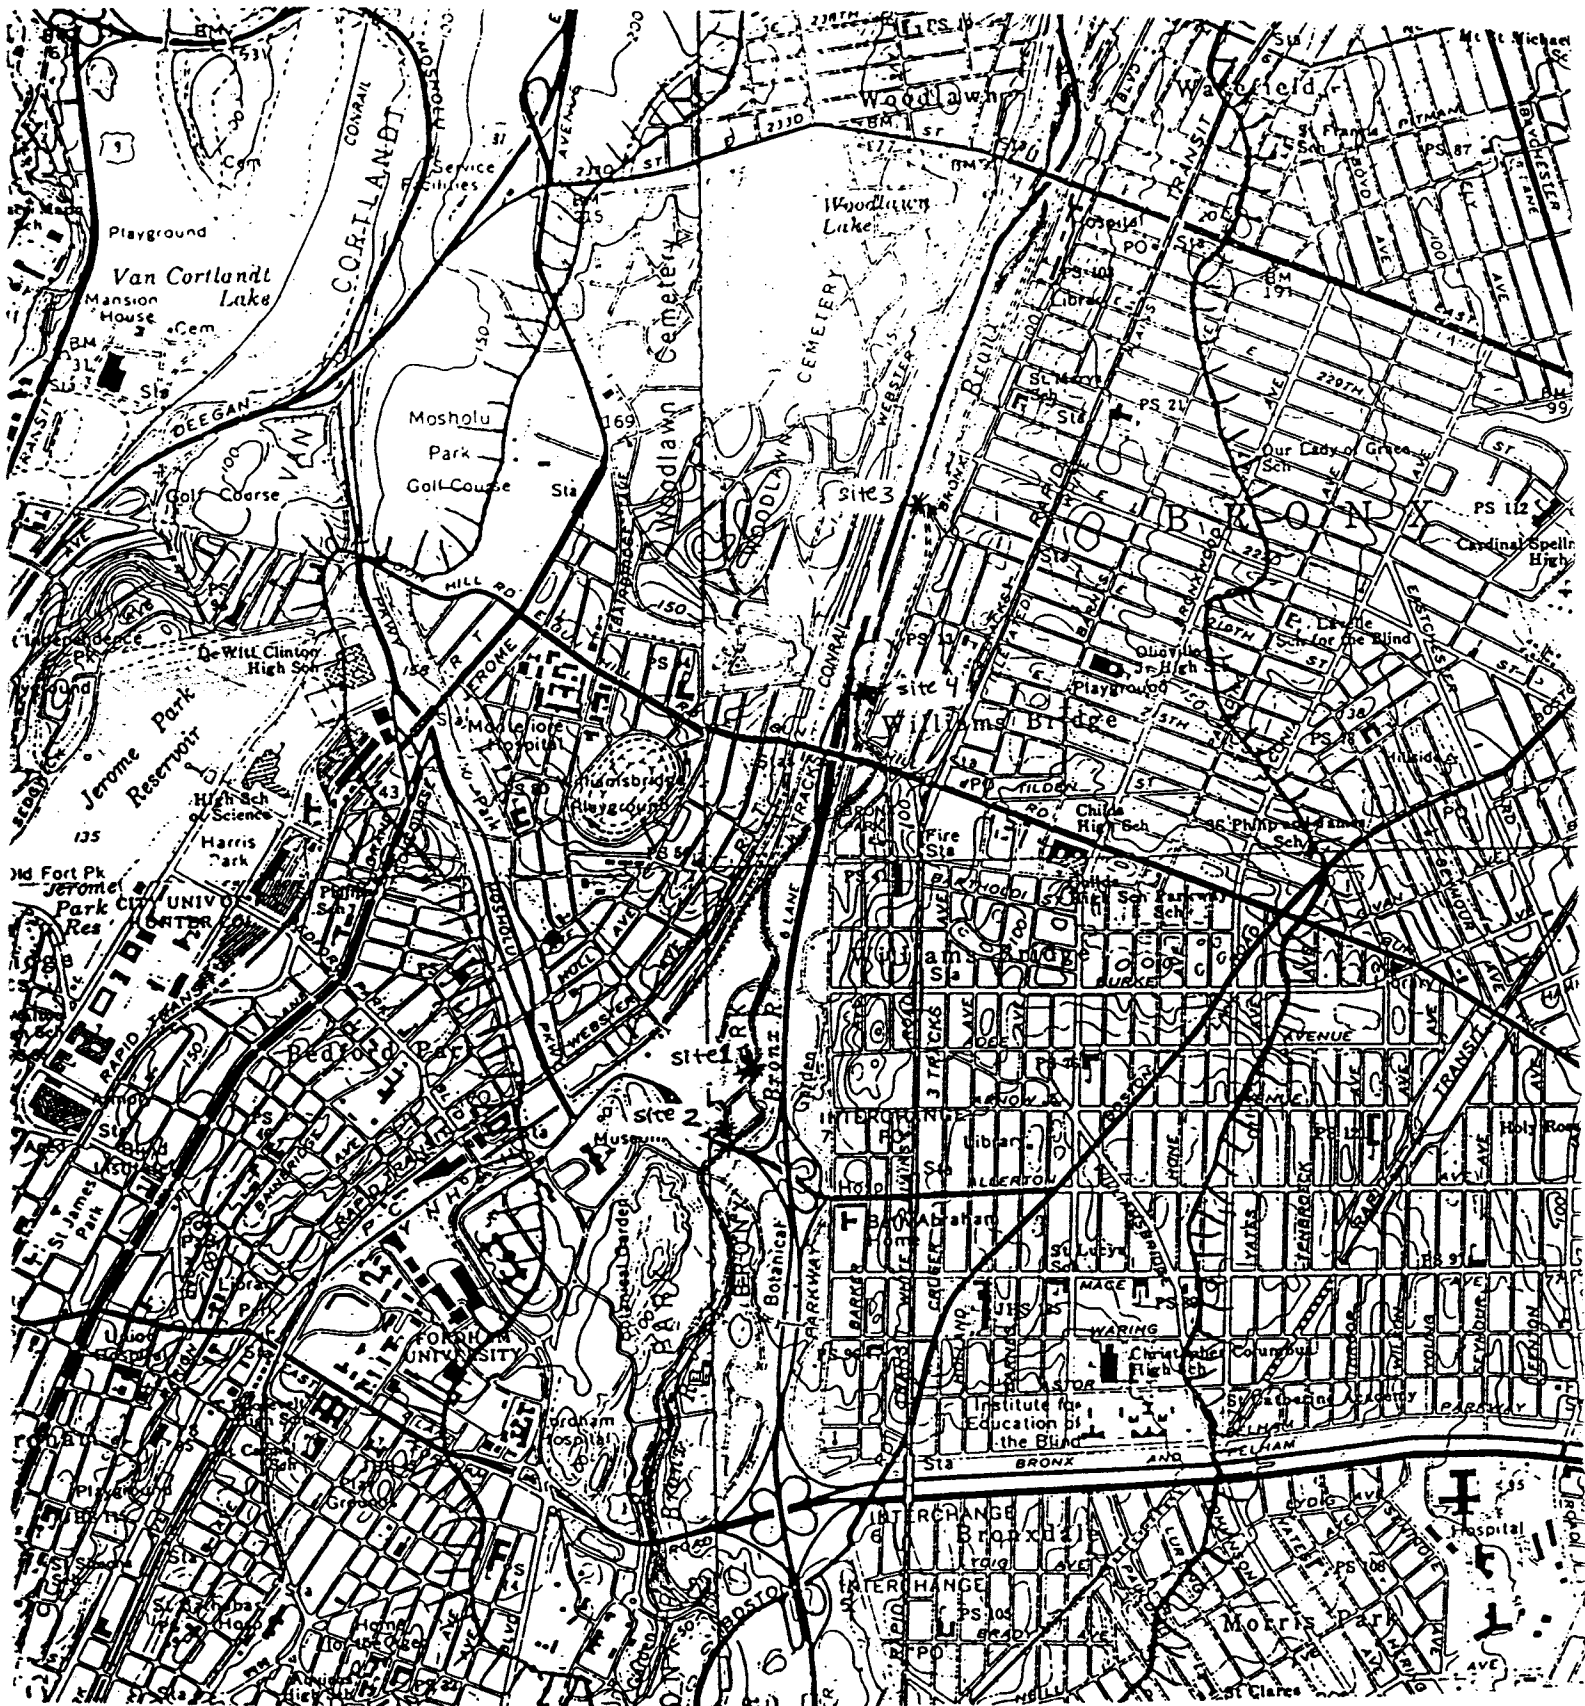
Appendix I

Red box indicates proposed restoration site.

Four sites were selected for examination. Sites one and two are in the north and south ends, respectively of the proposed restoration area. Sites three and four were selected for having comparable physical features with sites one and two such as current velocity, depth, and width. These two sites are north of the restoration site in Bronx Park (Appendix 1).
